Conservation of cultural heritage structures in seismic regions

P.B. Lourenço

ABSTRACT: The paper addresses different aspects related to the conservation of cultural heritage structures, with a focus on: (a) Behavior of masonry components under cyclic loading (tension, compression and shear); (b) Behavior of stone masonry shear walls under cyclic loading; (c) Behavior of dry masonry blocks and structures under dynamic loading; (d) Behavior of masonry arches strengthened with FRP; (e) Possibilities of numerical analysis at the laboratory and engineering levels; (f) An European Commission funded research project on reducing seismic vulnerability of cultural heritage buildings.

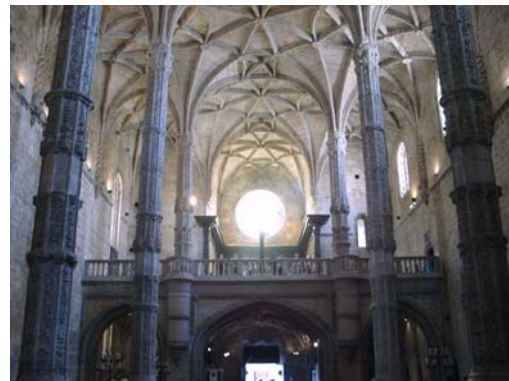
Figure 16. Monastery of Jerónimos: view of the nave and choir.

The church has considerable dimensions, namely a length of 70 m, a width of 40 m and a height of 24 m. The plan includes a single bell tower (south side), a single nave, a transept, the chancel and two lateral chapels. In order to assess the safety of the church, several in situ tests have been carried out: (a) three-dimensional survey of the church; (b) sonic and GPR tests in the columns to assess the integrity; (c) radar investigation to detect the thickness of the masonry infill in the vault and pier [10]; (d) removal of the roof, visual inspection, bore drilling, metal detection and chemical analysis of materials; (e) dynamic identification, see Figure 17 for examples.

interesting aspect appears in the 16th century, when the traditional three naves churches start to be replaced by a configuration with small difference in height for the naves. Here, the vault springs from one external wall to the other, supported in slender columns that divide almost imperceptibly the naves. From the traditional art, only the proportions and roof remain, being the concepts of space and structure novel. The fusion of the naves in the present Church, see Figure 16, is more obvious than in other manifestations of spatial Gothic. For this purpose, arches are no longer visible, the slightly curved vault comprises a set of ribs and the fan columns reduce effectively the free span. Additional information about the church and the vault can be found in Genin (2001).
